*Thatched Cottage
Church Street
Bampton
Oxfordshire*

*THE STORY OF
A HOUSE*

T. E. CROWLEY

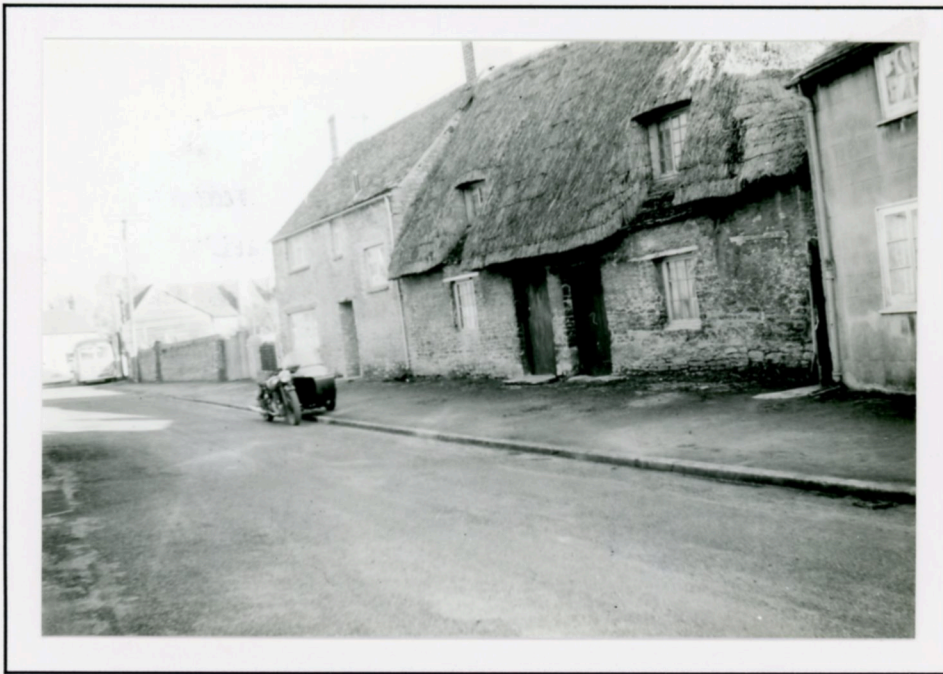
Unrestored, early 1963. Two doors, small workroom window and crooked lintel to blocked in window. Low irregular thatch.

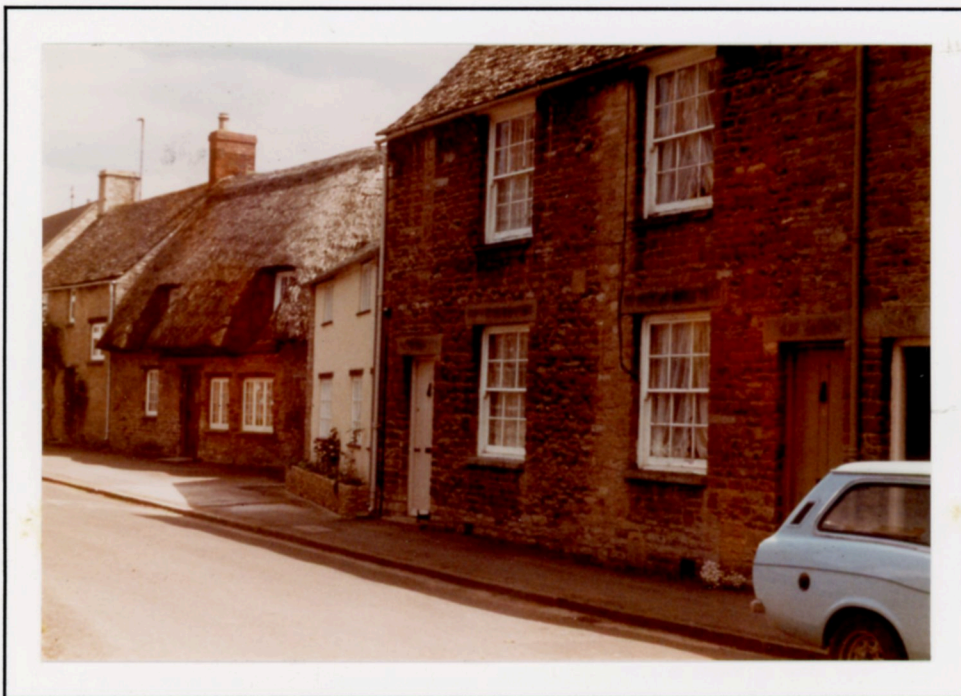
1981. The cottage stands back from the building line and at an angle to it. "Granny Houses" next door are angled to fill the gap (these are 1906, restored into one dwelling 1980).

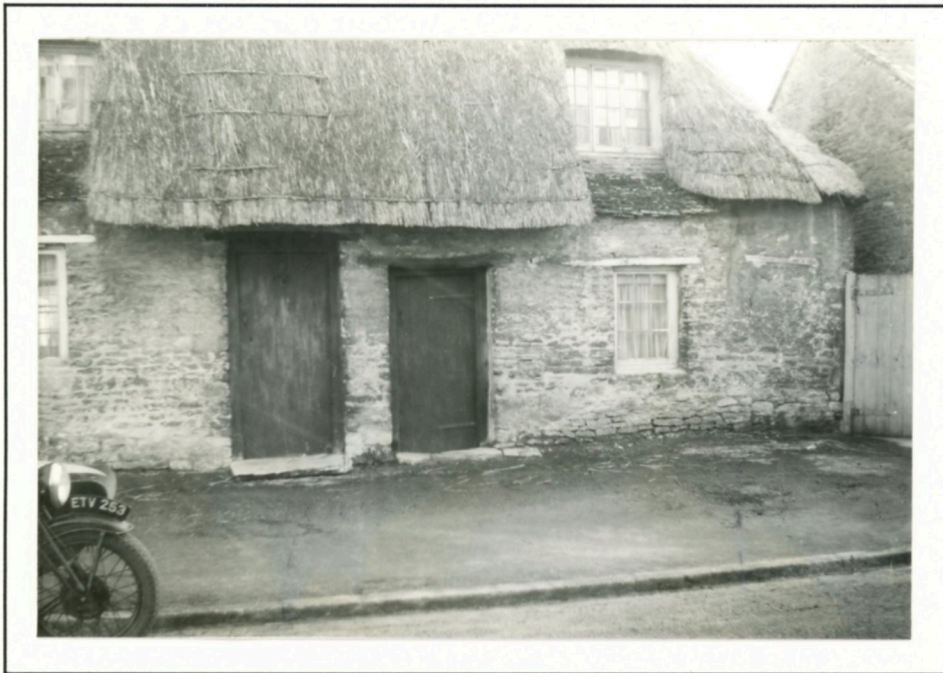
Original: Two front doors, one shorter. Small window under long lintel.
Note Stonesfield slating to upstairs windows. (1963).

irony → In those days there were two front doors side by side. It is evident that the building was originally two dwellings and there is just the thickness of the party wall between the two doors. One remarkable thing here is that the doors were of different heights approximately 6'1" and 5'6"; they were cheap plank and batten efforts not worth preserving; the right hand doorway we converted into a badly needed window. The front parlour window to the left, is of sixteen small lights, not designed to open, and made of pitchpine possibly suggesting a date of 1800-20. A similar version of nine lights lit the workroom (now the dining room), visible in the photo to the right of the doors, and this window exhibited the peculiarity of being a small frame under a long lintel. From being of identical size to the parlour window as built, it had been reduced when the frame was replaced, the gap being infilled with stonework. To the right of this again had been a small window under a crooked lintel and which had been infilled with stonework about 6" thick, leaving the lintel exposed on the outside and internally a recess, boarded up and framed by the original lining.

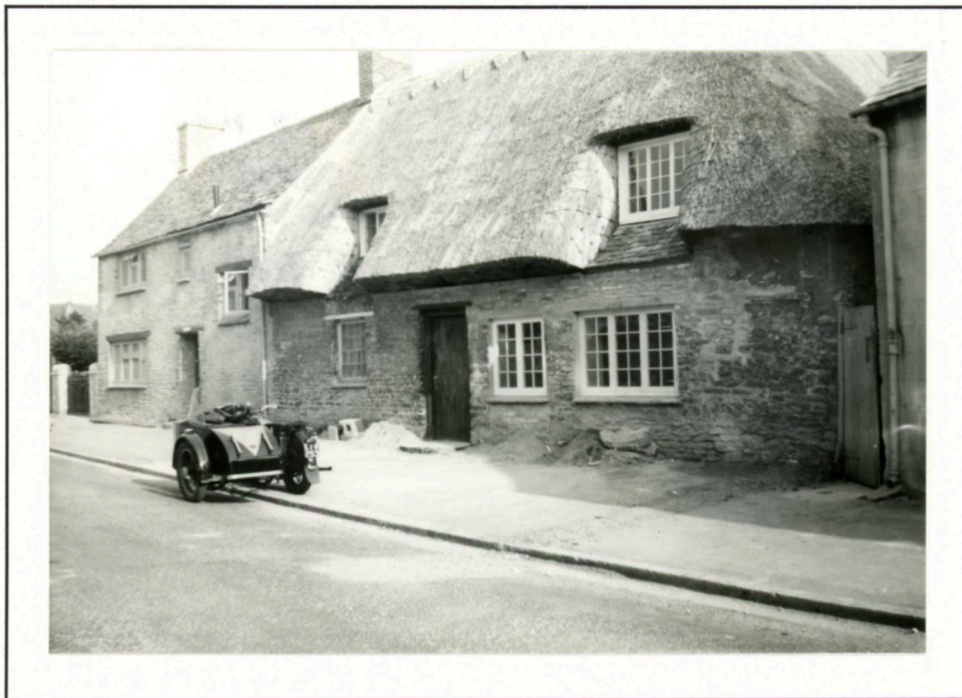
Altered: R.H. door becomes a window. R.H. window restored to original
size. Thatch cut back
upwards and renewed. (1963).

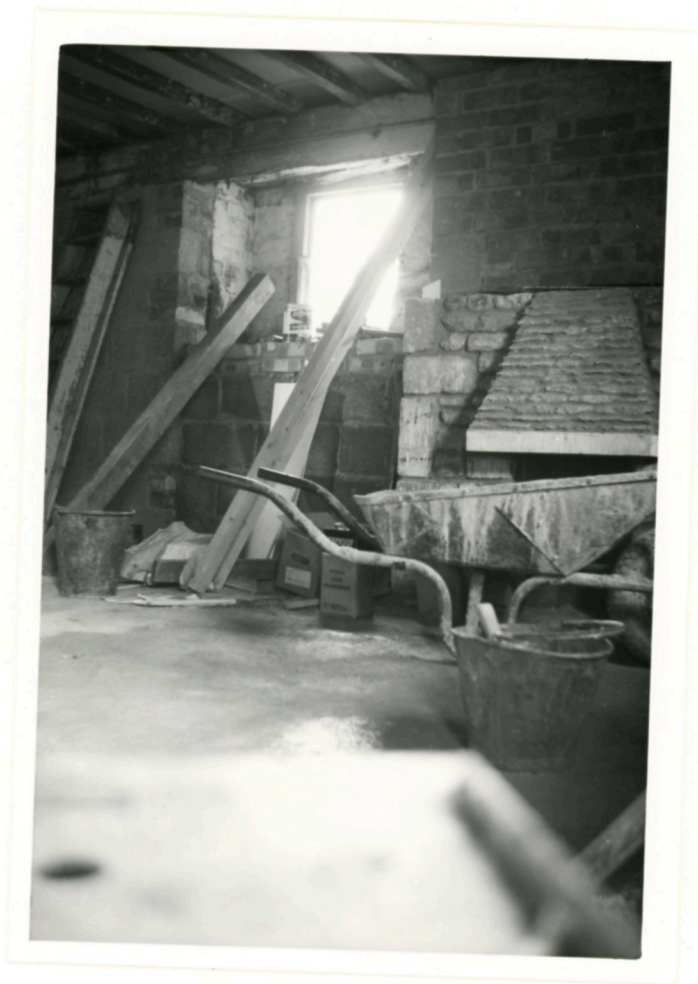
Workroom: Second front door open: walls un-plastered (as original). Diminished window to left. Church pillar supporting decayed end of central camber beam (1963).

The exposed ceiling joists are of elm, most of them pitsawn, but about four look older and darker and have been adzed and chamfered. The central bridging beam is similar to these, also adzed and chamfered and was evidently re-used out of some other structure. It shows surplus joist holes and may be older than the house. It had rotted and failed at the outer end and was supported by the turned pitchpine pillar from the gallery in the church. When the structure was repaired I put the pillar to support the centre of the beam, largely as a 'feature', since it in fact does no work. The stud wall of the lobby provides support for the beam from this point.

A striking feature of the room is that the ceiling joists are not taken into the walls of the room but are supported either side on pitsawn ledge beams roughly 8" square, and this is proof that the upper floor was added subsequent to the original building. The fireplace in the centre of the west wall, my design, cuts through one of these beams. Before the installation of the fireplace there never seems to have been any form of heating in this room except, after 1893, the fire under the wash copper which was built into the south west corner and the chimney of which now takes the kitchen boiler. How the room was used a hundred years ago remains a mystery.

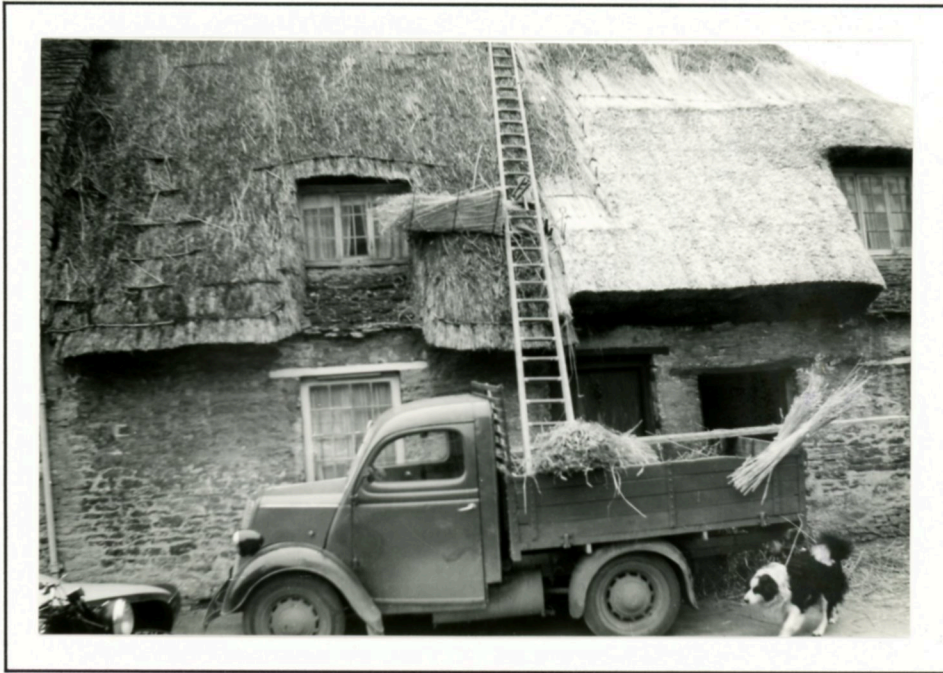
Re-thatching: a foot higher than before (1963).

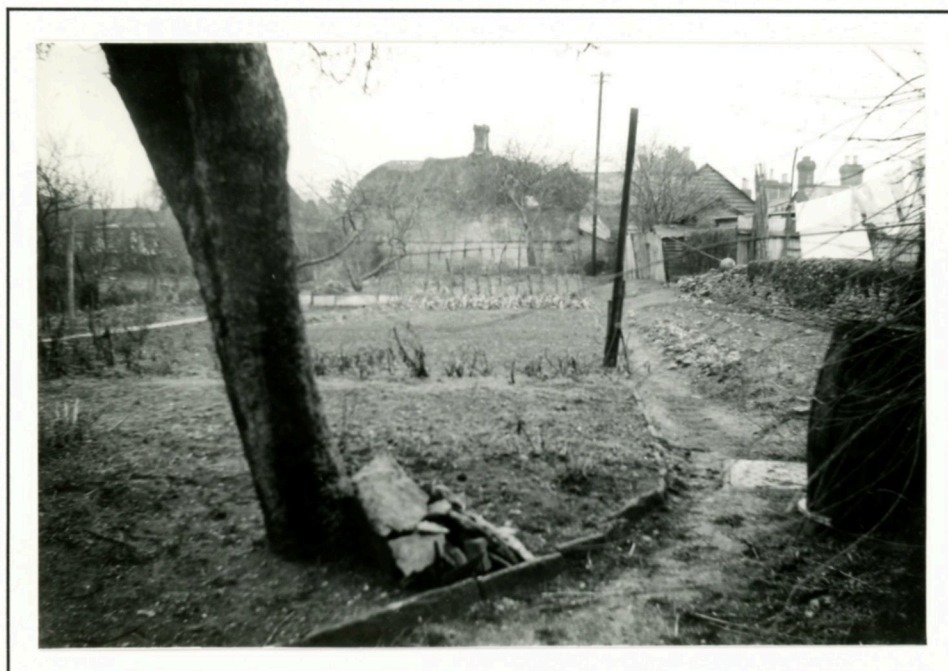
Looking up the garden: Plaster's shed on right. Derelict 'barn' with chimney behind dying appletree, centre. (1963).

The garden is about fifty five yards long, L-shaped at the end where it encompasses the next garden on the left, and bordered on the right by a Cotswold stone wall and Arthur Plaster's shed, where that craftsman spent his last years, as did his Father and Grandfather before him, producing magnificently finished woodwork. There were two rather aged apple trees in the garden, one at the bottom end which died suddenly and promptly fell down, and the other, an Alington Pippin, though decayed in parts, survives and gives varying quantities of excellent apples. Halfway up the garden, where the pond is now situated, there used to be a large 'double walnut', a tree of some local fame it seems, but this had fallen before our time although the trunk still lay about. The garden was in use as an allotment when we came, worked by Fred Lomas, who lives opposite in Belgrave Cottages and was a distant relative of the Radbands (see later). The domestic rubbish tip was evidently at the rear of the garden to the right, and this yielded small pieces of iron such as wellhooks, window stays, a trivet, an inkwell, the iron ring and rivets from a patten, and miscellaneous pieces of pottery.

Thames Valley fossils, typical of the floodplain gravel and all well worn and rolled, consist mainly of *Gryphaea* and belemnites. At the end of the garden, and forming its border, was a ruined barn-like building, thatched and with a chimney, probably the one mentioned in the 1789 survey, and possibly as old as the cottage. This was demolished when the present two storey house was built, but the remaining portion of its north wall still borders the garden at its south end.

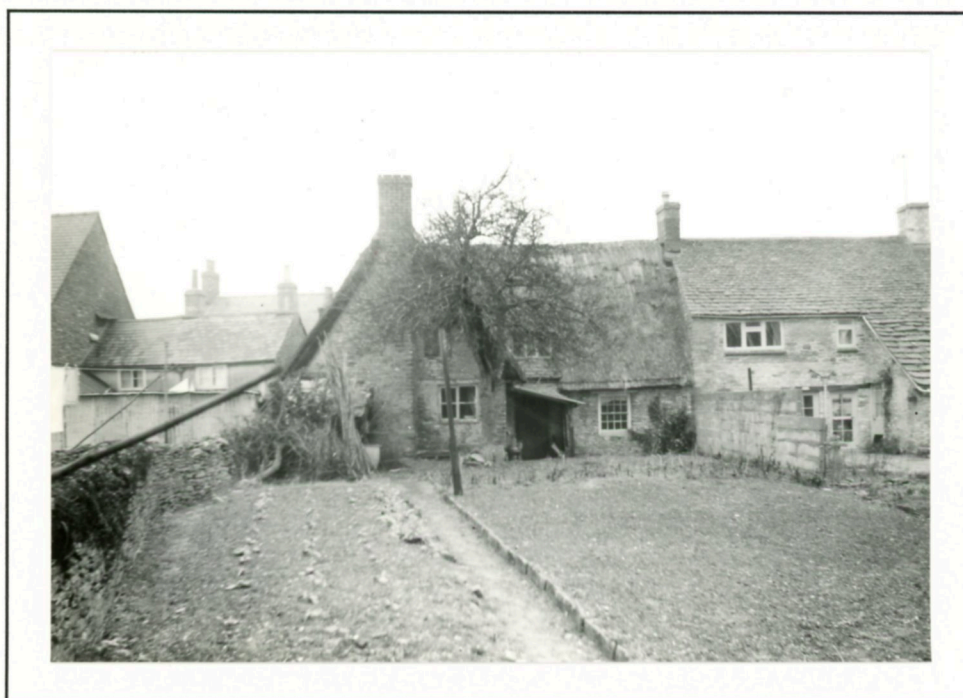
Garden; looking north to the house before re-thatching. Tiny 'Granny Houses' next door and 'Roseann', semi-detached, right. (1963).
Building block wall recently erected by Jim Slatter.

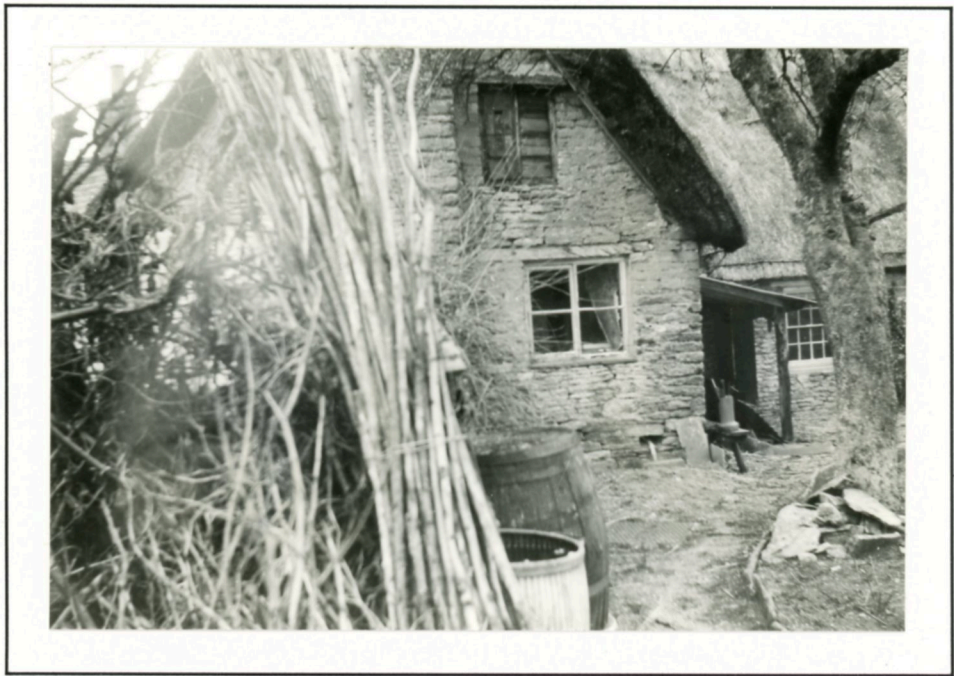
South kitchen window and that to the tallat above had both been reduced in size.
Note corrugated shelter to back doors.
Pigstye was in tangle on extreme left. (1963).

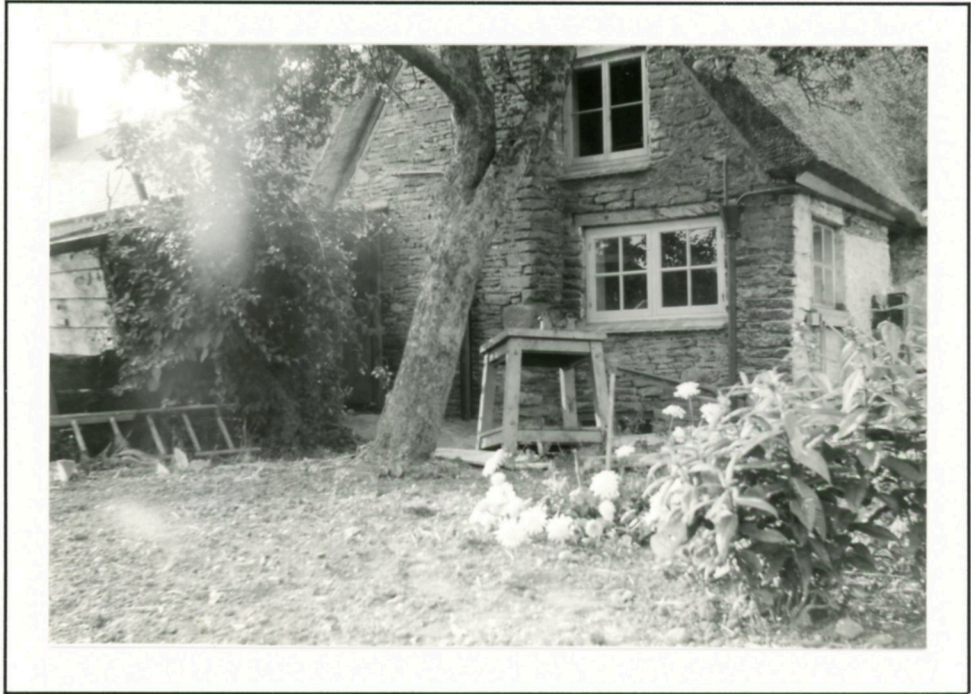
Same windows restored to original size and reframed.
Shelter to back doors removed (whitewash under). Sunroom not yet built
but plumbing installed (1963).

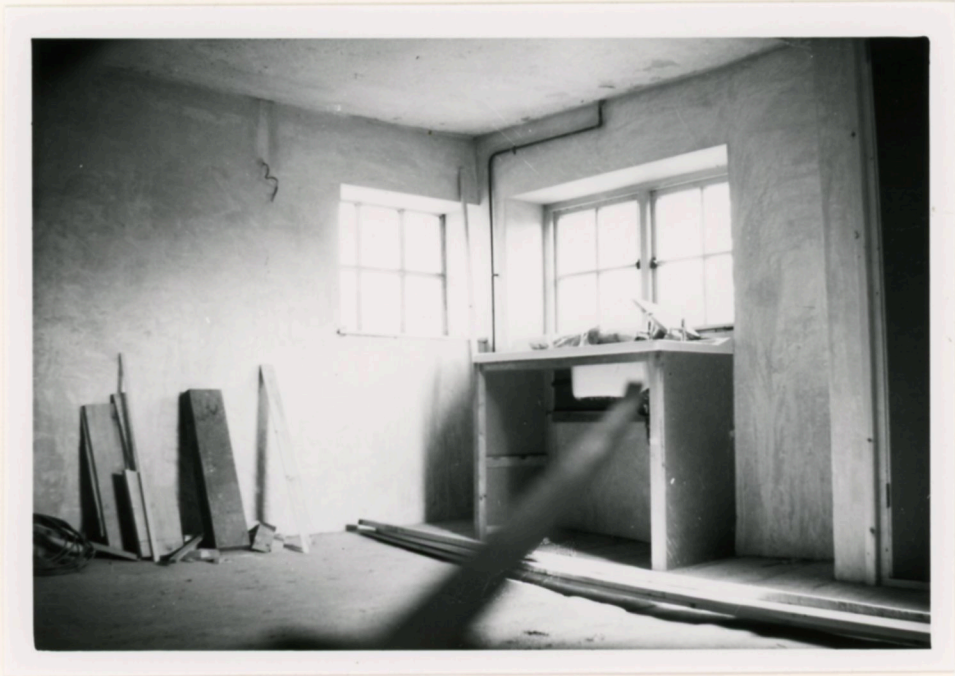
Kitchen, S.E. corner (see pic. on right).
South window enlarged, sink moved to S. wall

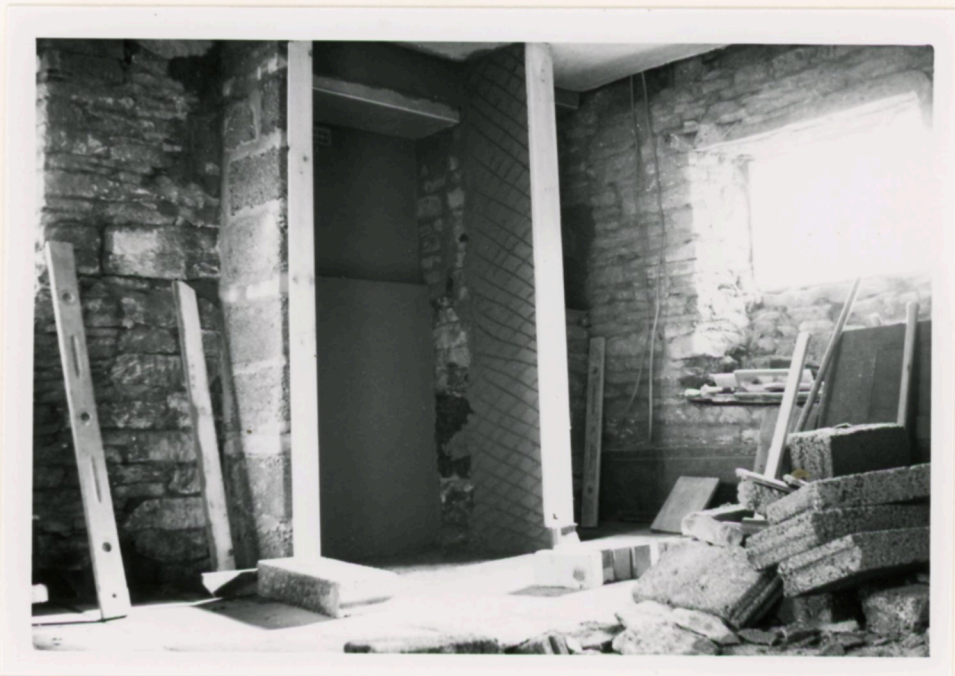
Kitchen: S.W. corner (see pic. on right). Overmantel
to kitchen removed, food cupboard being constructed

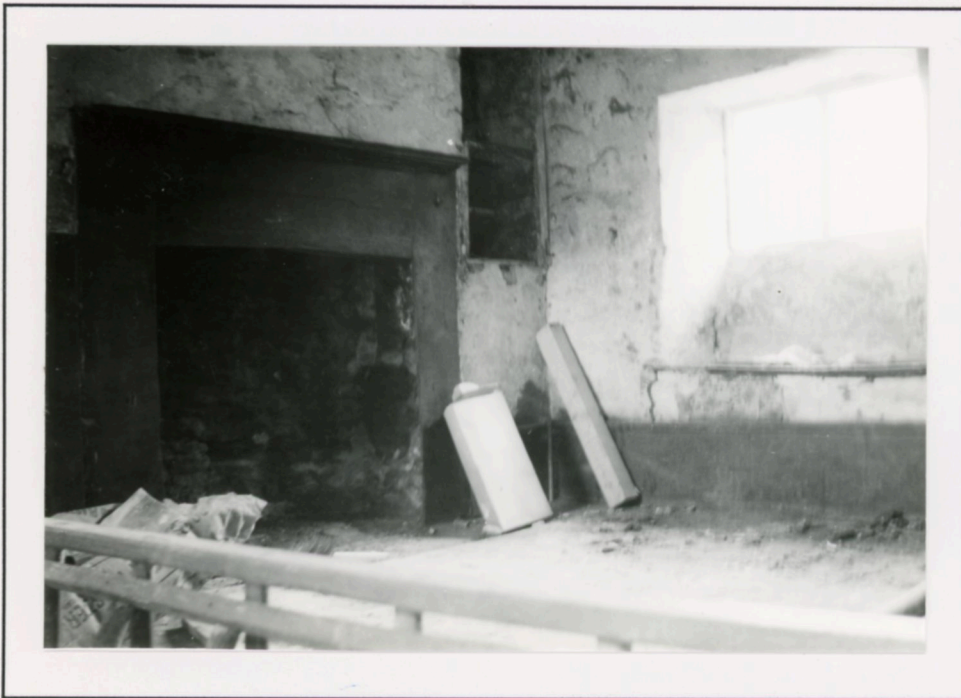
Kitchen: South west corner. Kitchen range has been removed. Over mantel remains pro tem. Deep alcove in extended external chimney breast, centre. (1963).

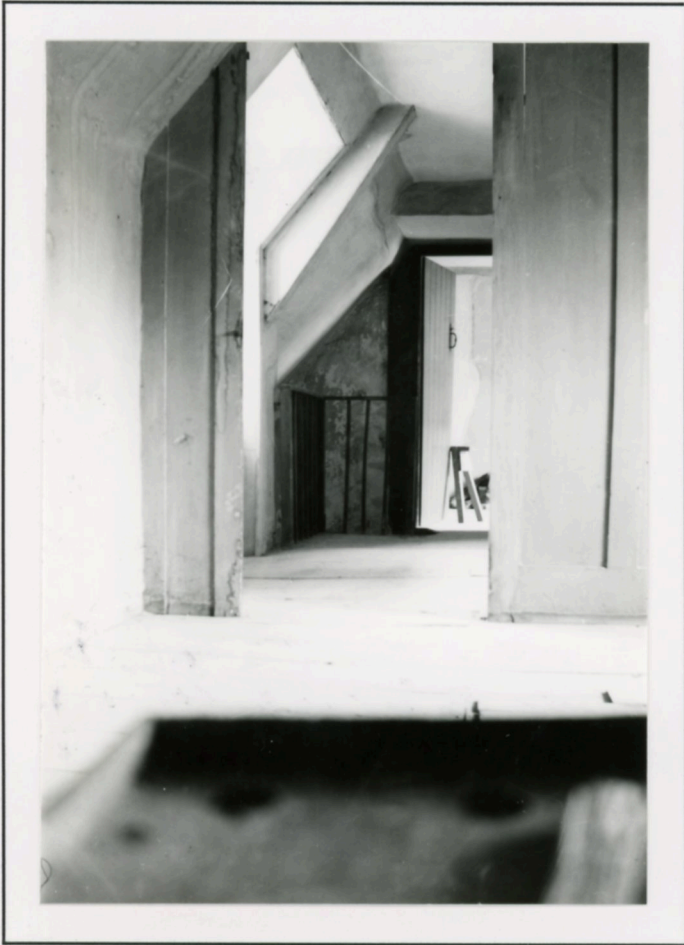
Main bedroom looking west to stairtop and second bedroom, through the door to matchboard partition which divided the main bedroom into two. Note flimsy banisters, rain streaks on walls. (1963).

When we came, the bannisters at the stairtop were of the flimsiest, and we replaced these with panelling capable of being rapidly dismantled for getting furniture up and down. Even then, the wardrobe had to be sawn in half; certainly the idea that the carpenters of old always kept in mind the need for bringing a coffin down the stairs does not hold good in the meaner dwellings of Oxfordshire.

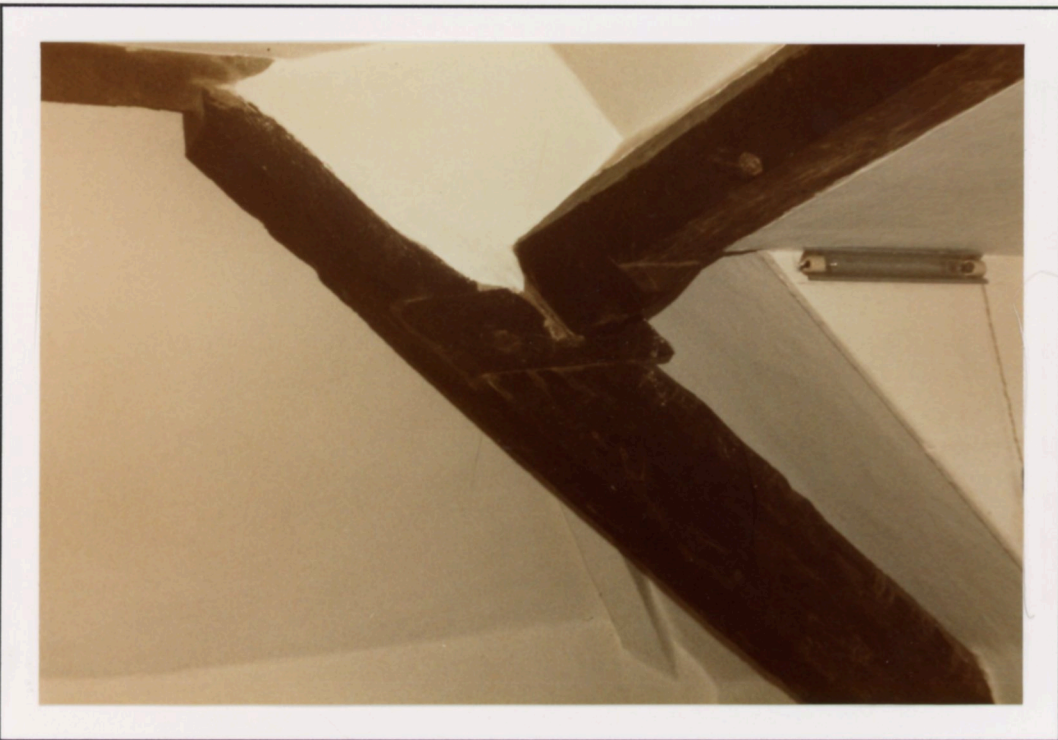
Corner diagonal beam in second bedroom, free of the roof structure: put there possibly because the window gable beam was not long enough to reach the opposite wall. Even then the joint seems to have been botched with an inserted cradle.

Later: this is half of an original (c.1500) cruck

The stone walls disguise two bays of a timber-framed house. Three principal trusses survive, mostly boarded over but accessible under the eaves on the N. side, where the wallplate can also be seen. The outer (i.e. W.) face of truss A-A1 is heavily weathered, suggesting (despite two inexplicable pegholes in the end of the N. purlin) that the house originally ended here. At the E. end, however, the S. purlin continues at least 1 m. beyond the line of truss C-C1, indicating that there was once a third bay; this is corroborated by the wallplate scarf mid-way between posts B1 and C1, which would be the central point in a three-bay house, and therefore the appropriate place to joint two equal lengths of timber.

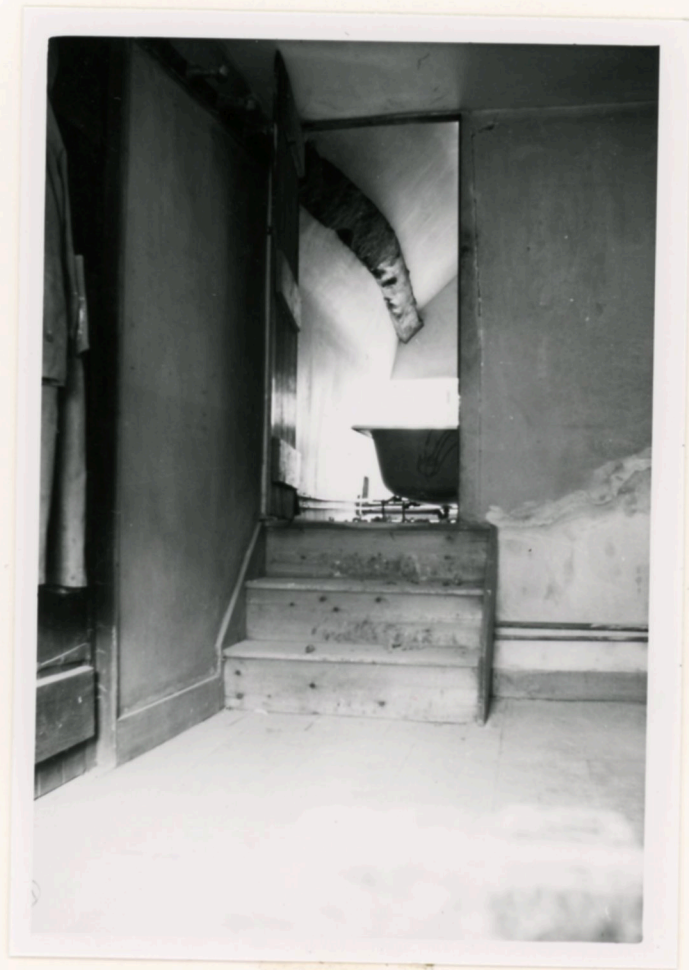
Steps up to tallat (now bathroom) above kitchen

The tallat made an excellent bathroom and it is certain that without this area we could not have converted the house. We created walls five feet high and ceiling with coving between the two, naturally leaving the big elm purlins exposed. The collar was removed and replaced above ceiling level. The area of the room was reduced by these measures but it is still amply big enough for its purpose; I am only sorry that I was not in a position to take a photo of the room in its original state.

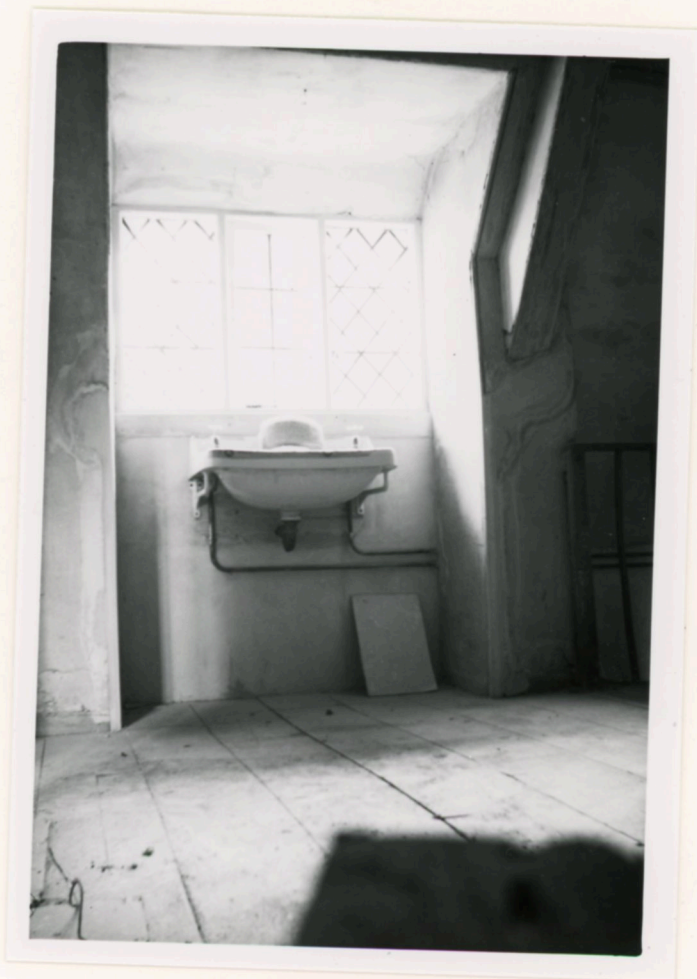
Washbasin installed in south recess
in main bedroom

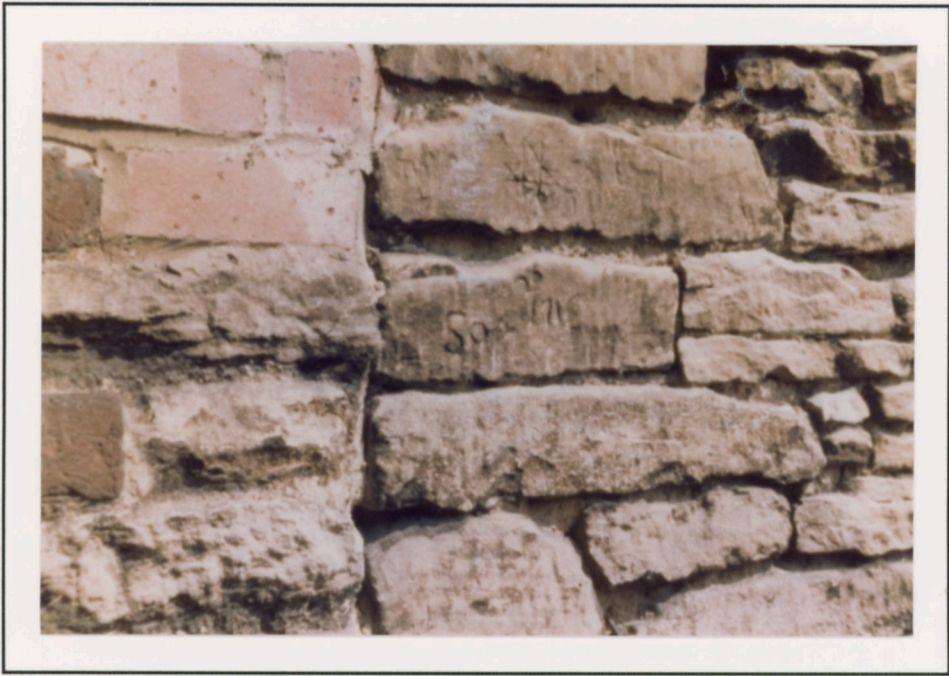
WEST WALL (1980)

Older work with
modern chimney
insertion

Construction
Joint

? 1716 etc
